SKYLAB MISSION REPORT
FIRST VISIT

PREPARED BY
Mission Evaluation Team

NATIONAL AERONAUTICS AND SPACE ADMINISTRATION
LYNDON B. JOHNSON SPACE CENTER
HOUSTON, TEXAS
August 1973

This report constitutes the Johnson Space Center's evaluation of the first visit. The report is presented in two parts, and contains the information available 30 days after the completion of the first manned visit.

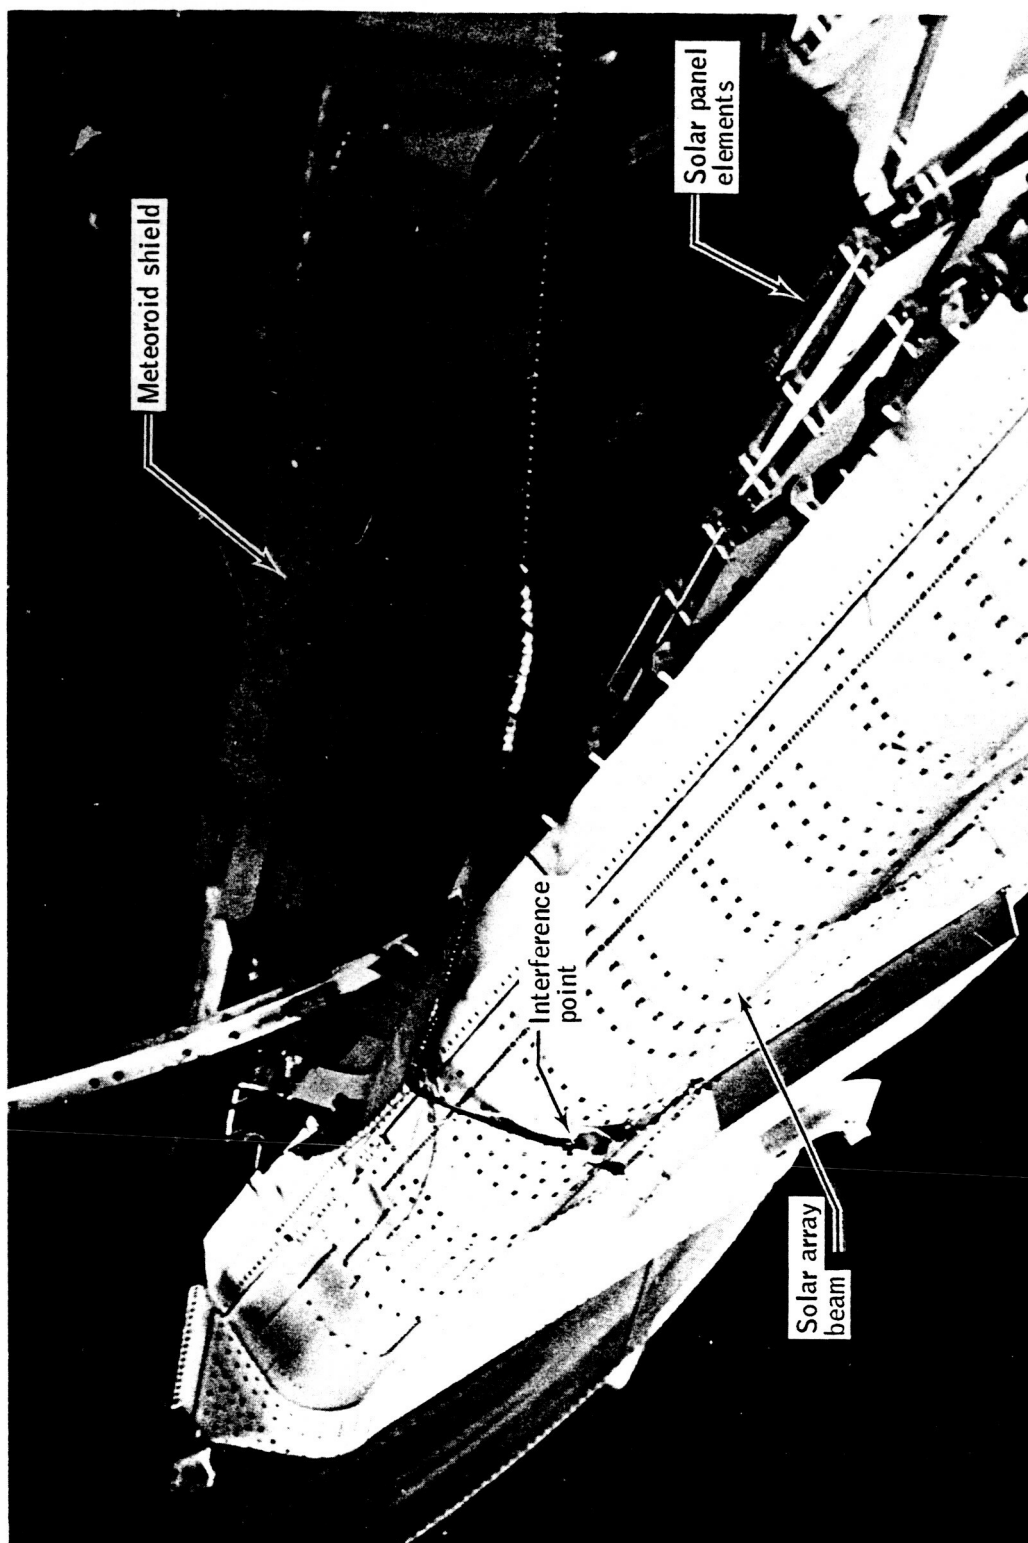
Flight film results indicate that the system functioned as expected in documenting several inflight anomalies of other systems. The electronic flash greatly enhanced the interior photography. The closeout photography using the electronic flash is of particular value in establishing the Orbital Workshop condition at the end of the first visit. Figure 11-1 is a photograph showing partial deployment of the wing 1

Figure 11-1.1.- Solar array wing hangup during initial flyaround with 35 mm camera and 300 mm lens.

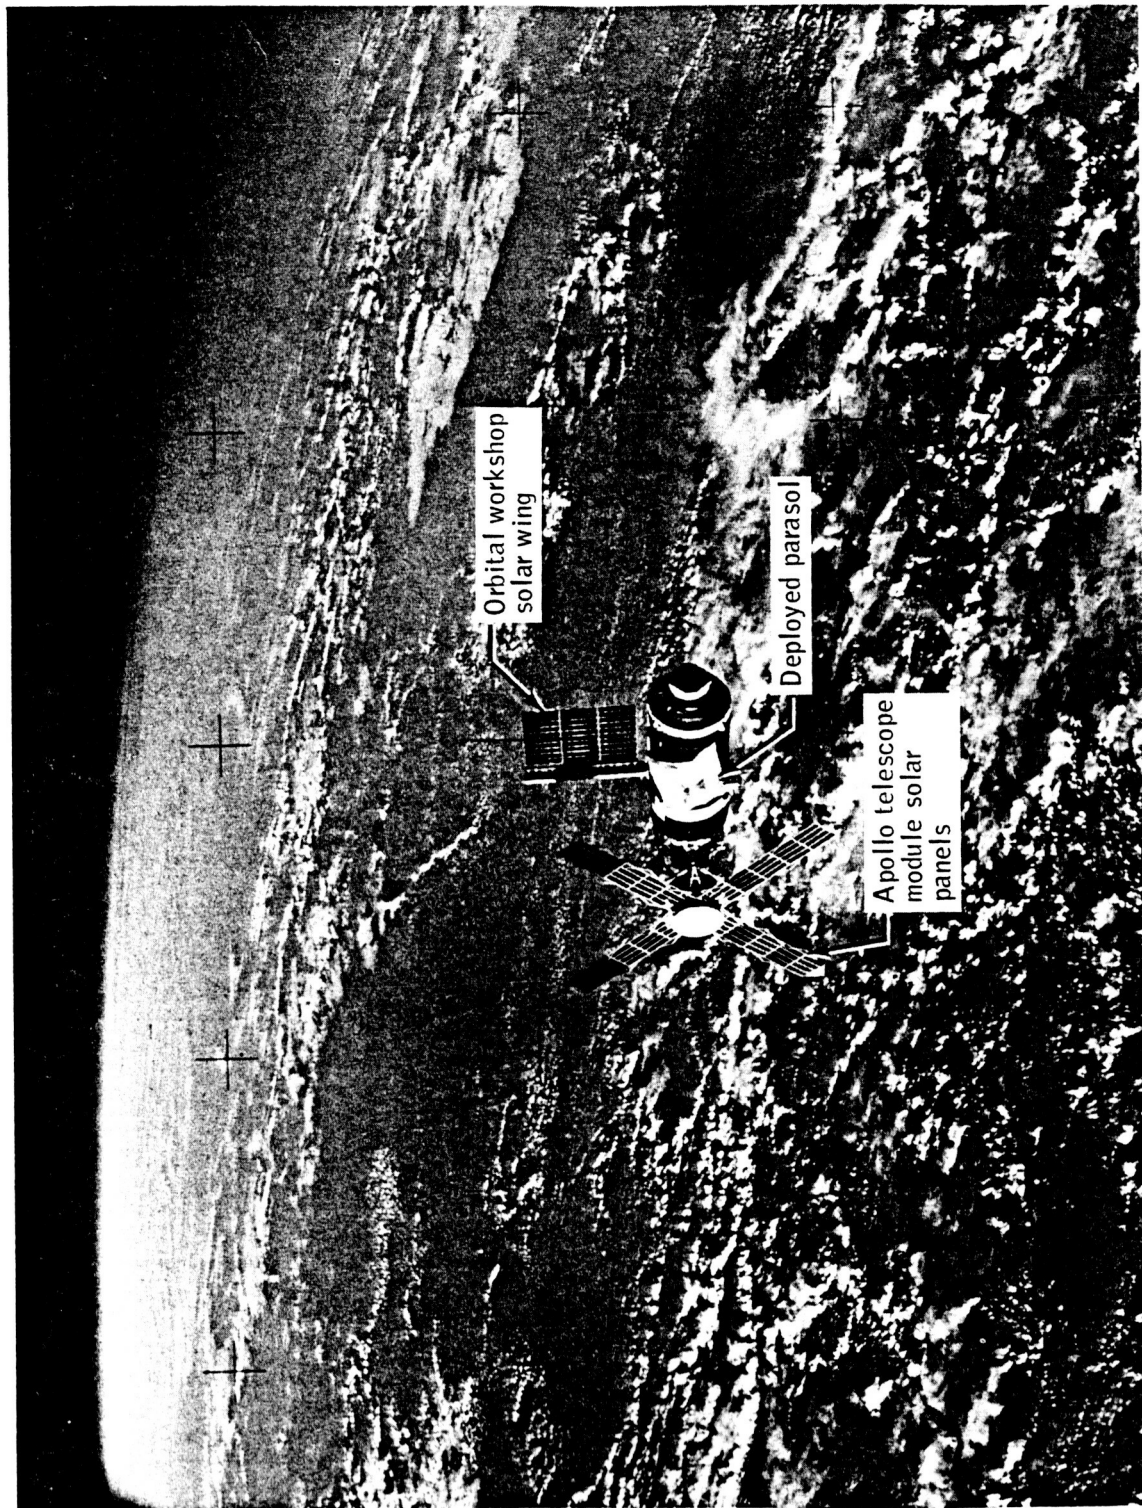
Figures 11-3 and 11-4 are examples of 70 mm photography. Figure 11-3 is a picture of the Saturn Workshop showing the configuration prior to command and service module docking. Figure 11-4 shows the Saturn Workshop configuration after extension of the wing 1 solar arrays and deployment of the Skylab parasol.

Figure 11-4. - Saturn workshop during final flyaround inspection.

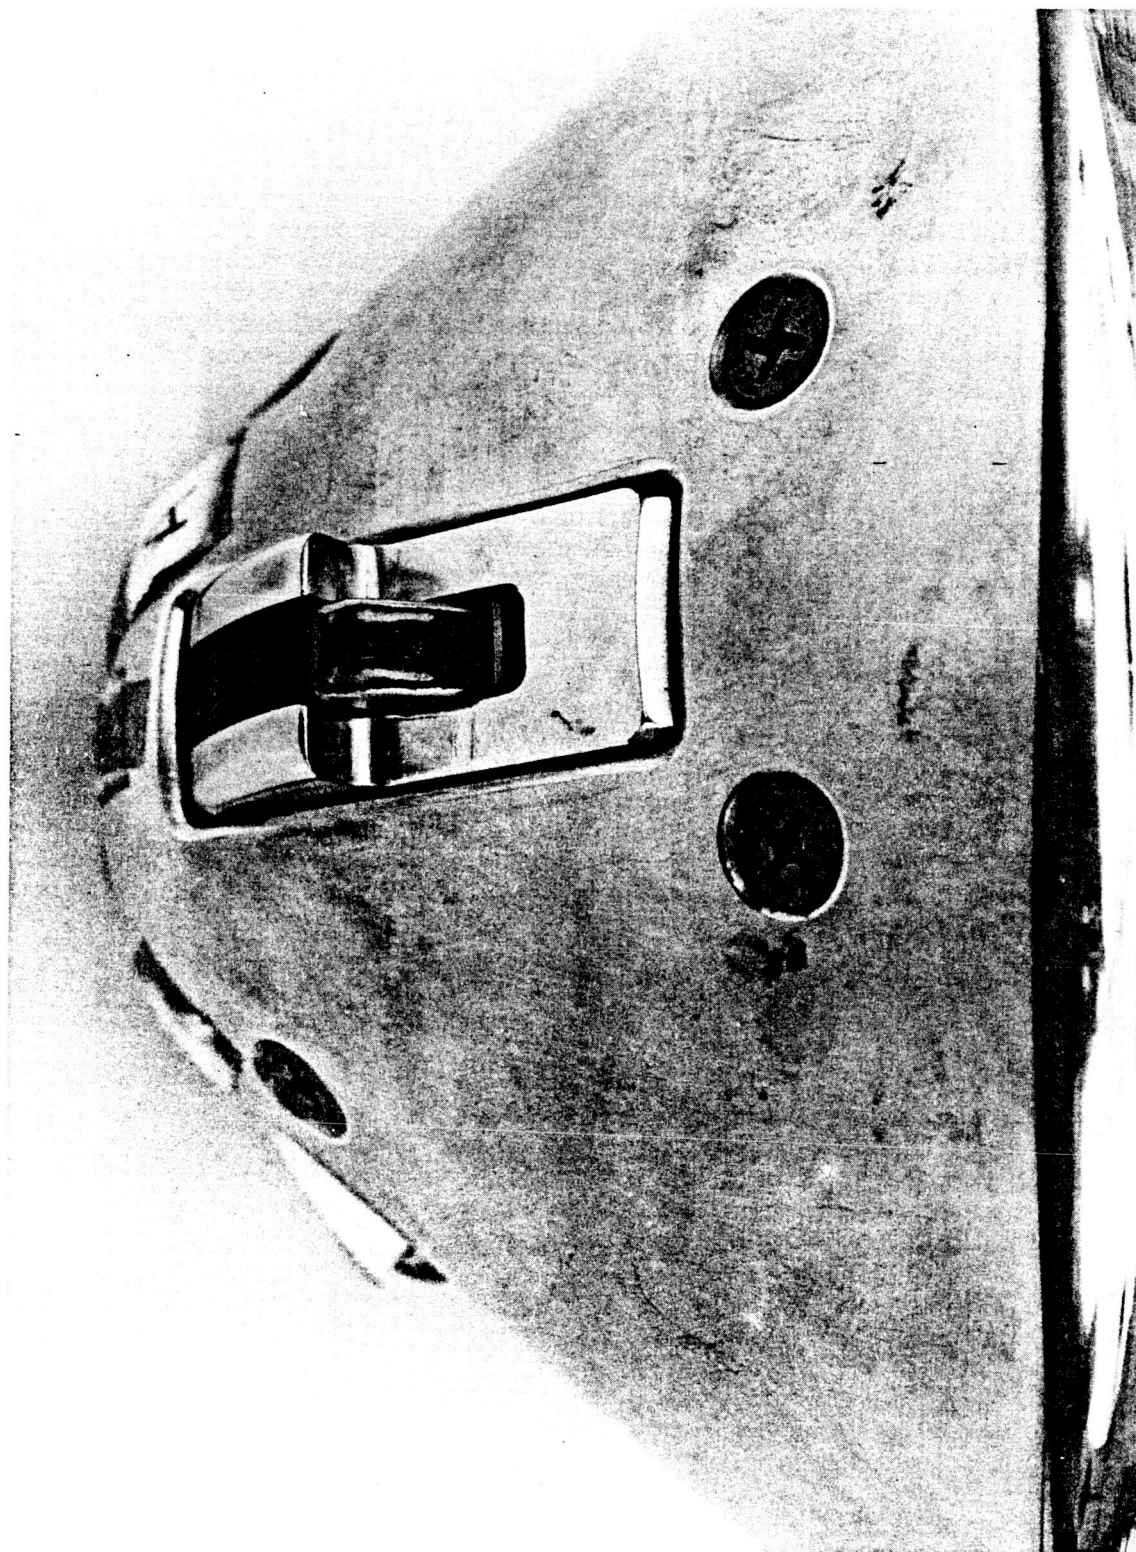
Figure 17.1-11.- Probe cover.

- a. Dimensional tolerances for the slots in the cap have been changed to eliminate any possibility of overhang.
- b. Additional assembly level dimensional and force measurements are being performed.

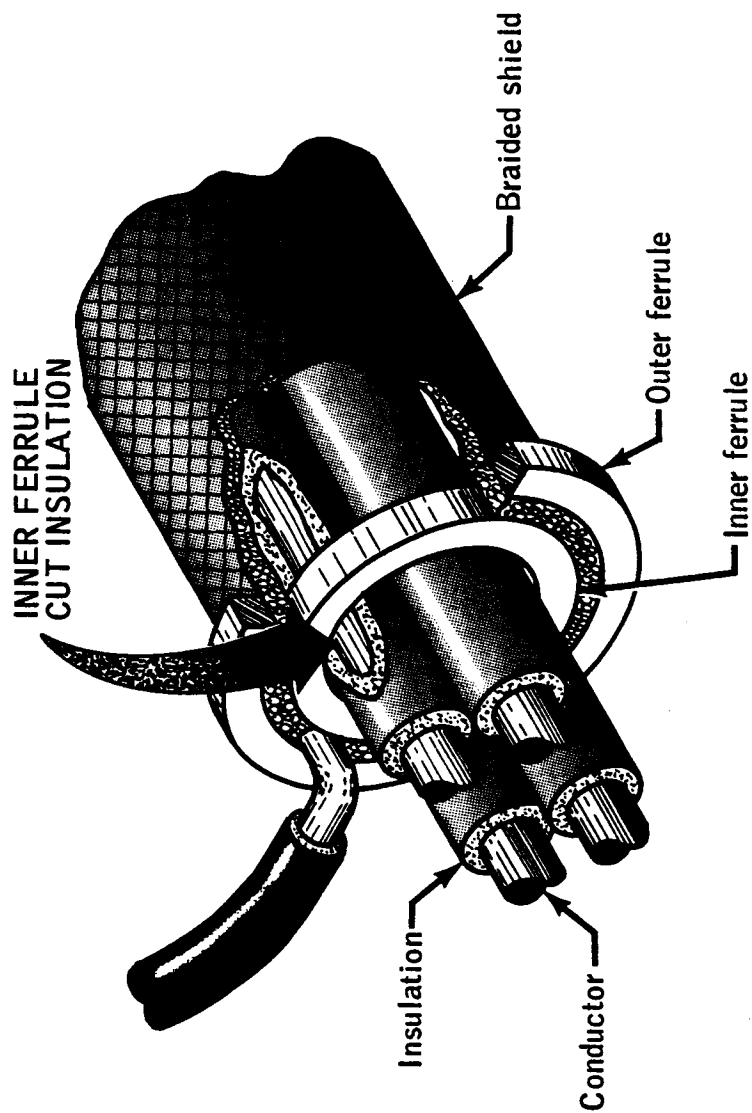
The transducer cable shield is connected to ground at the signal conditioner. The shield connection is made by crimping two ferrules around the cable, the first under the shield and the second over the shield. Shorts have previously occurred because the inner ferrule was too small for the wire bundle and cut through the wire insulation during assembly

Figure 17.1-14.- Short in wire bundle from conductor to inner ferrule to braided shield.

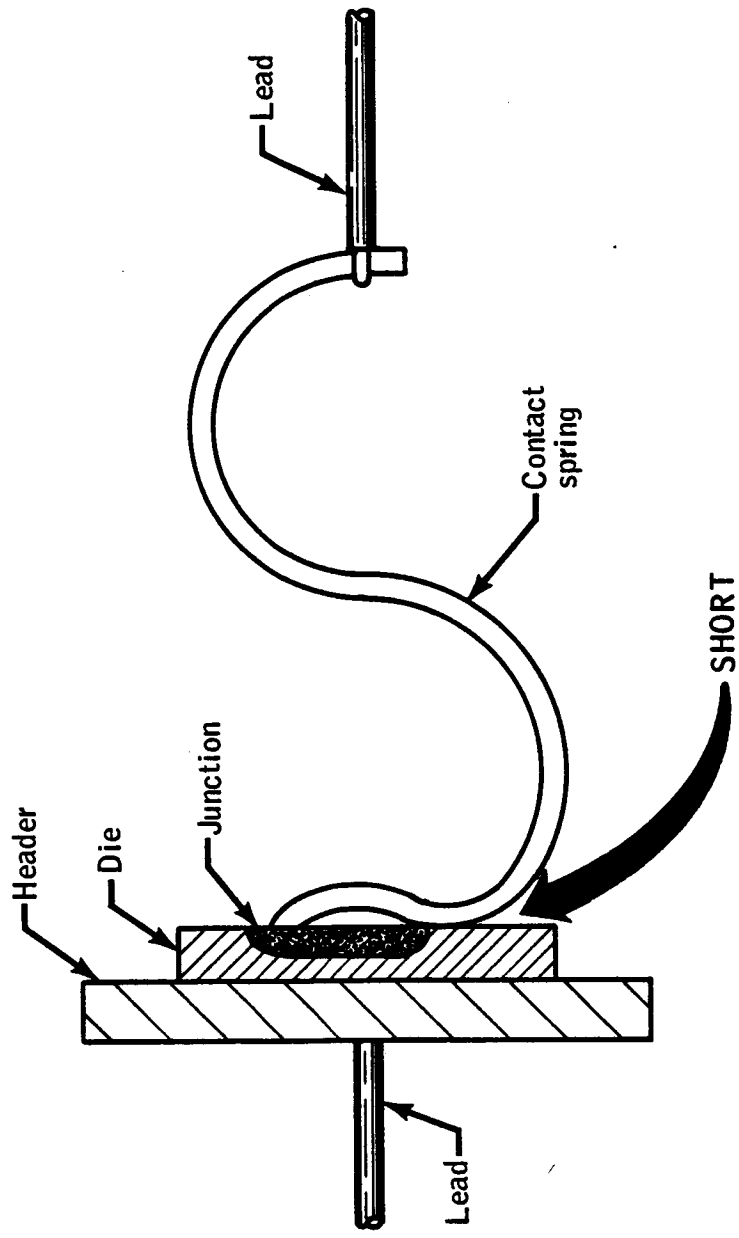
The diode junction was shorted by conductive contamination inside the diode glass body. The contaminant particle appeared to be a sliver of silicon that had broken off the semiconductor die and migrated to the junction, shorting across the junction. The sliver was fused to the die surface, bridging the junction.

Figure 17.1-17.- Shorted diode.

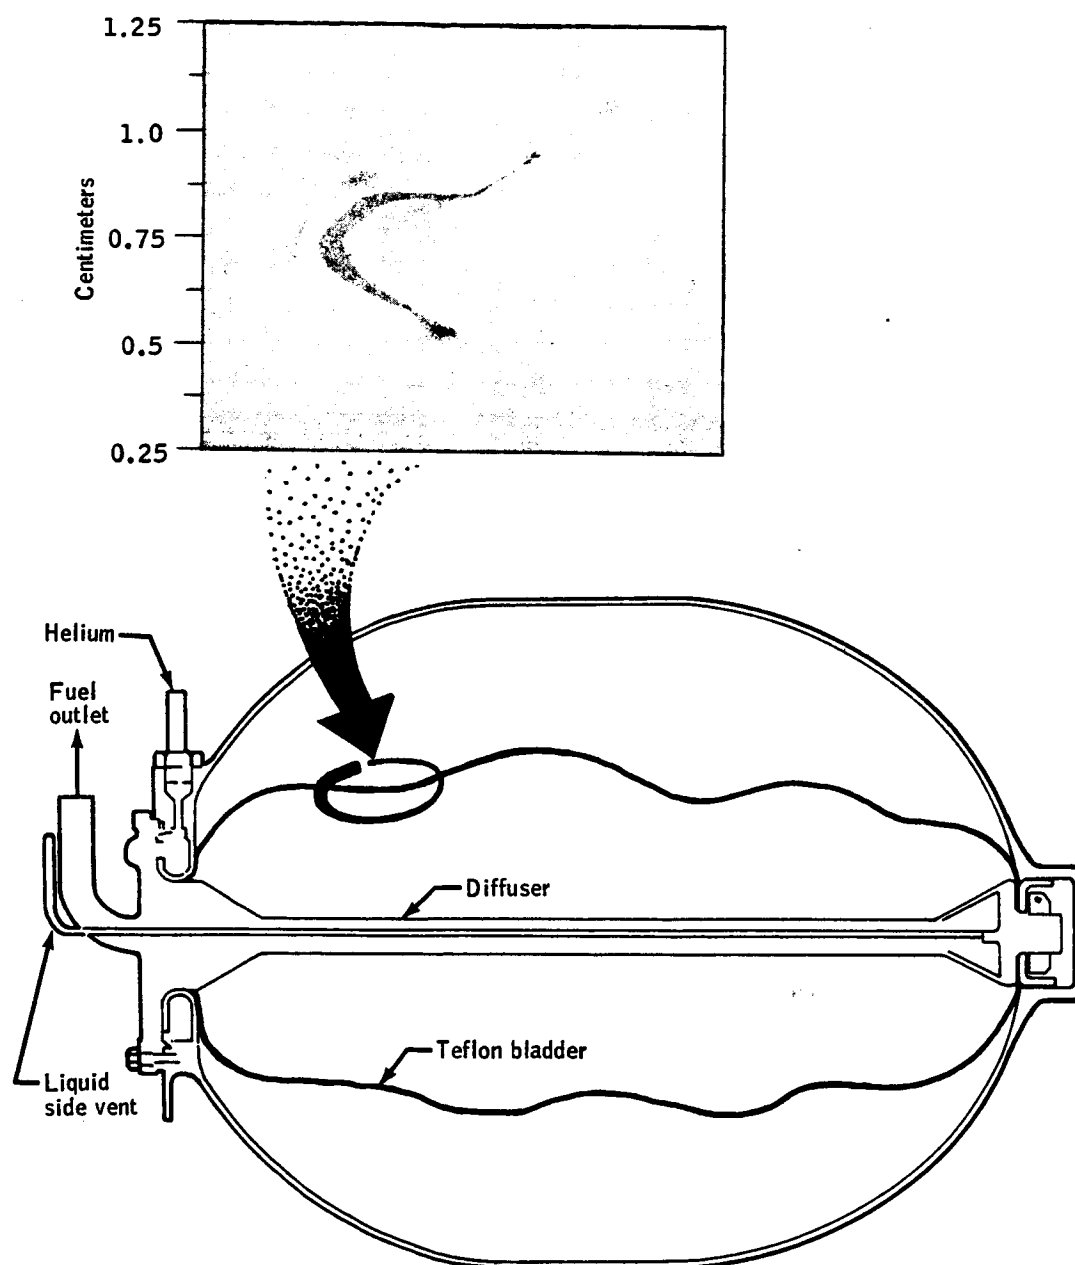
The fuel tank was removed from the spacecraft and the postflight decontamination leak was confirmed by an additional test. The bladder was removed from the tank and a visual examination showed a U-shaped cut (or tear) approximately 0.3 centimeters long (fig. 17.1-20). No contaminate that might have caused the cut was found on the bladder or in the tank. The standpipe and tank were also examined for surface irregularities and were smooth.

Figure 17.1-20.- Torn bladder in reaction control system fuel tank.

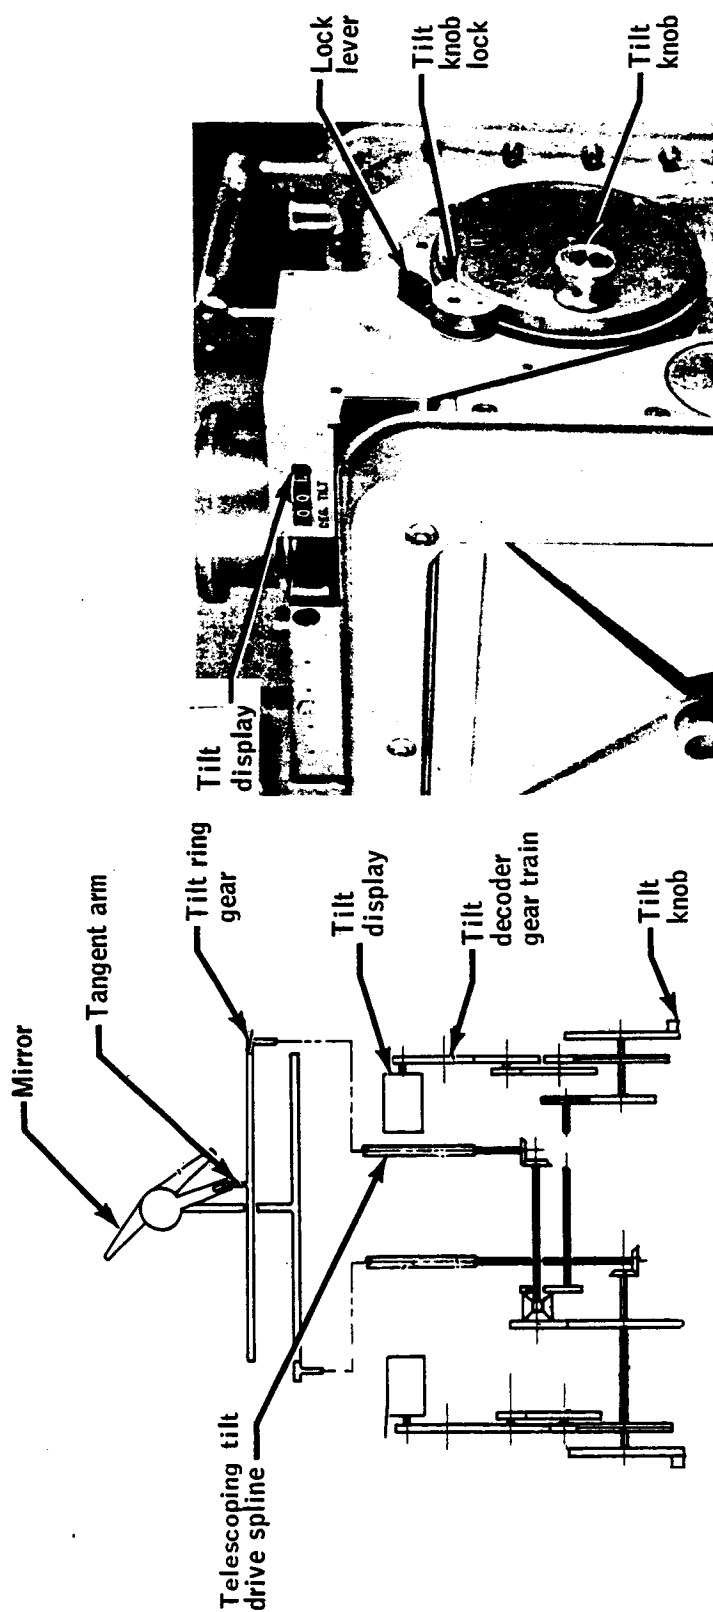
During the initial activation of the S019 experiment, the tilt mechanism was found jammed. The jamming was isolated to interference between the tilt display gear clamp screw and the aluminum cover. A repair procedure teleprinted from the ground corrected the problem and restored the experiment to normal operation. Details of this anomaly are given in section 17.2.3.

Figure 17.2-3.- Experiment S019 mirror tilt mechanism.

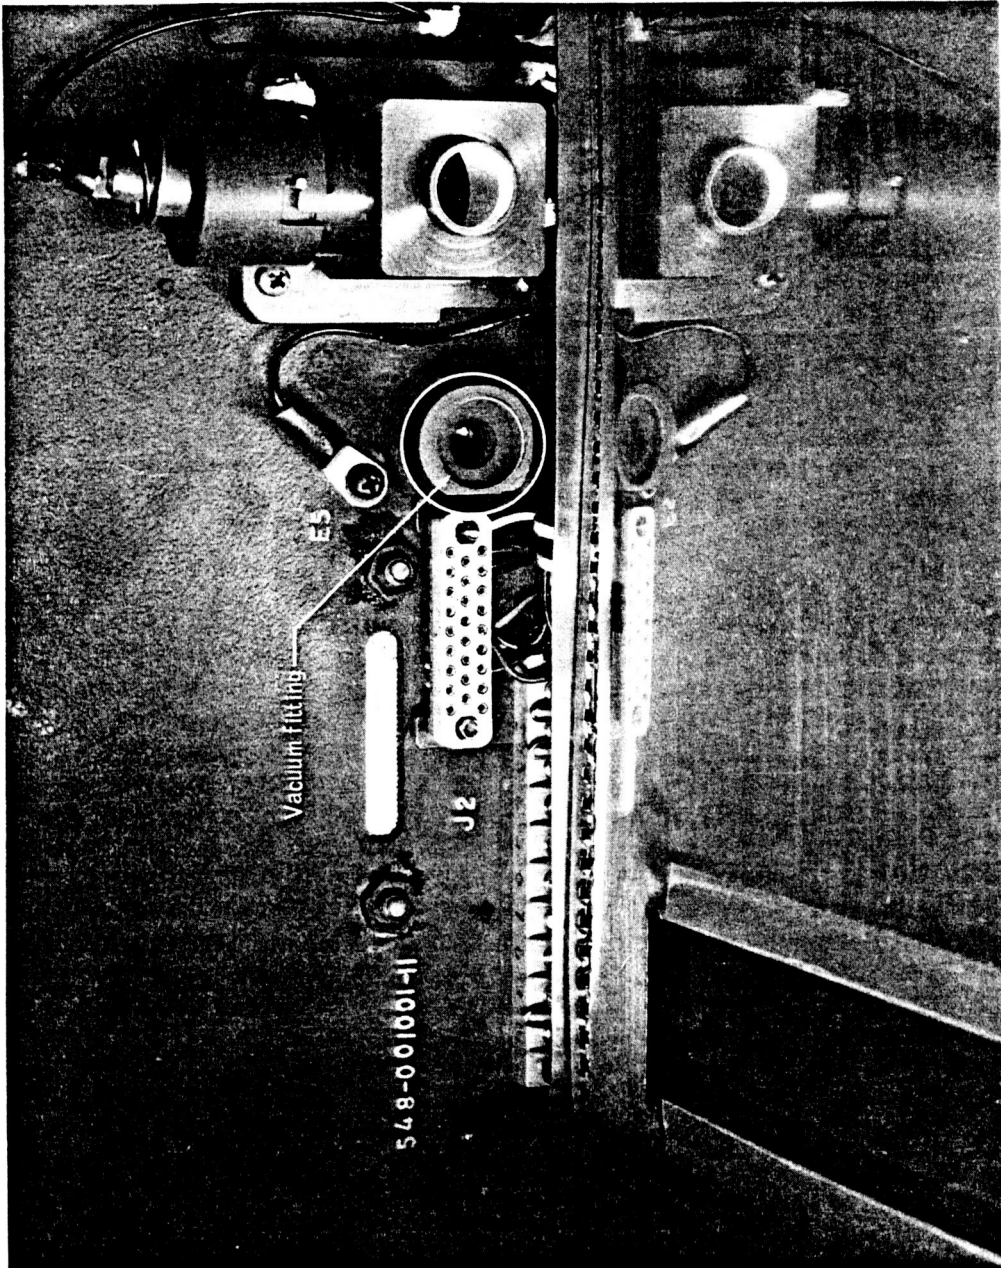
Figure 17.2-9.- Magazine vacuum fitting.

Placing a double shouldered elastic grommet over the magazine vacuum tube was proven to be an effective seal for the case of a tolerance offset.

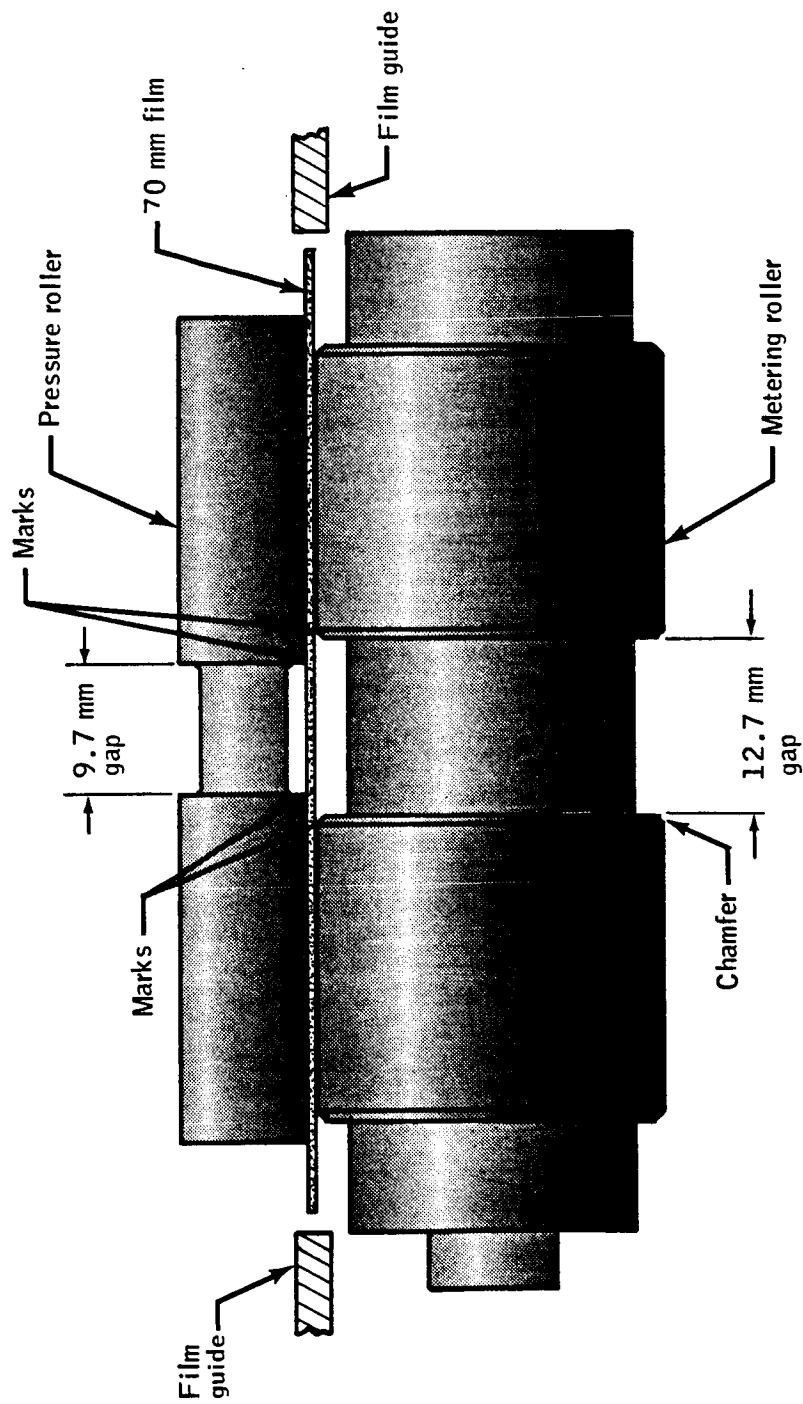
Figure 17.2-12.- Metering and pressure roller assembly showing the roller gaps correlating with the film marks.

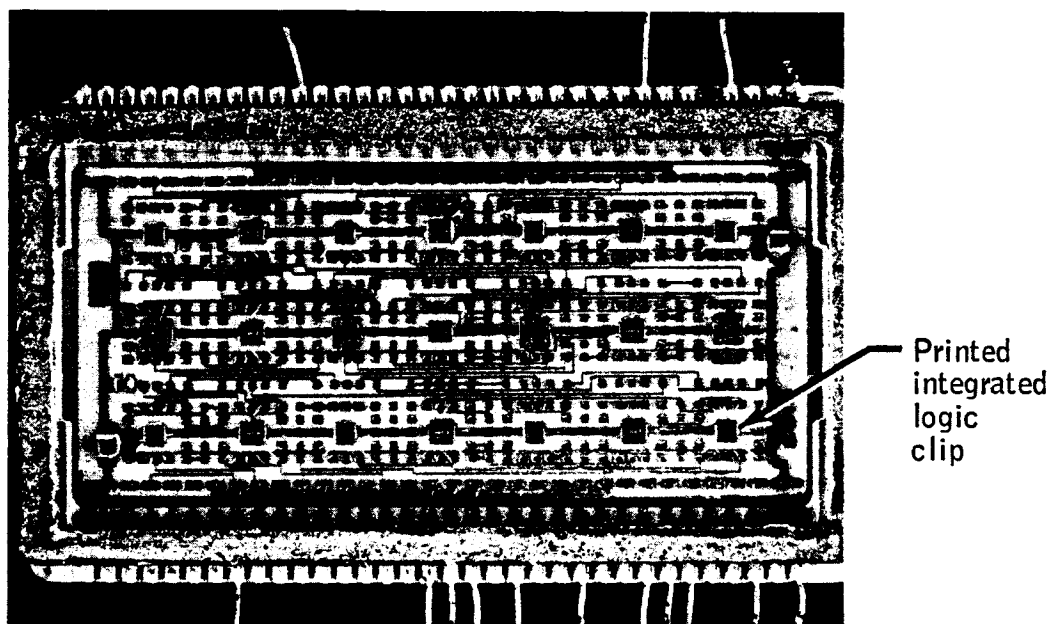
Postflight testing verified the failure was in the multichip hybrid synchronous generator package. No synchronizing signals were being generated, thus depriving the entire camera of triggering and timing signals. Without timing, there is no color wheel drive phasing signal, the tube assembly deflection coil sweep is not properly generated, and the video processing circuitry will not function.

(a) Contaminated synchronous generator with lid removed.

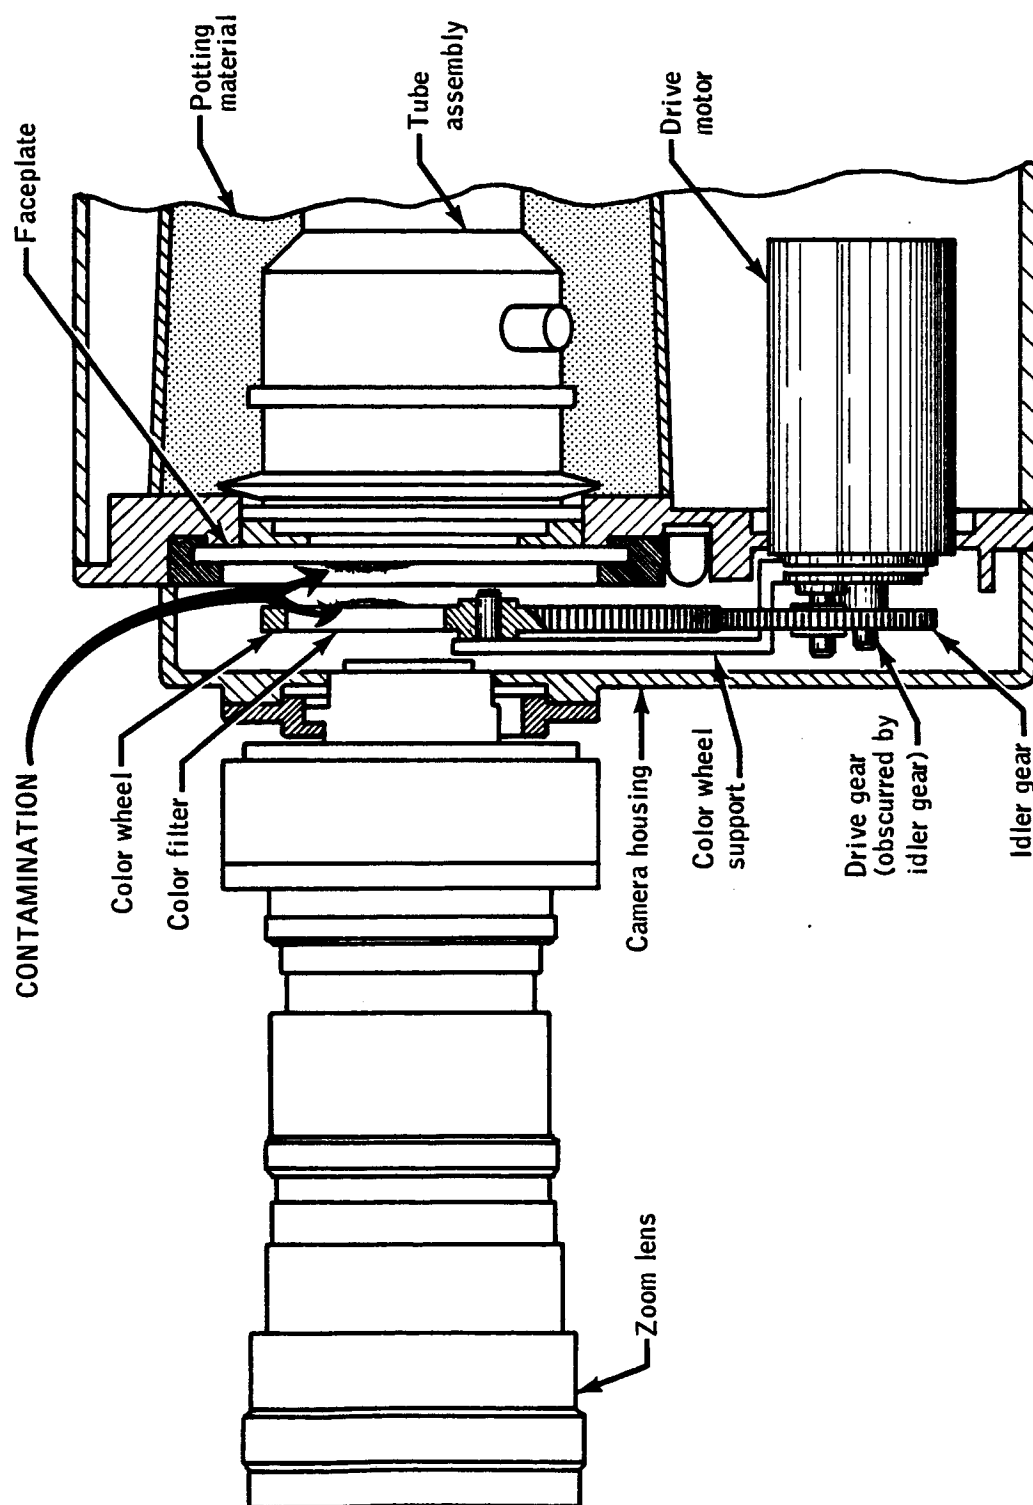
Figure 17.3-4.- Contamination location within television camera.
